11. TITLE (Include Security Classification) Corrosion Phenomena During Overcharge in Polymer Electrolyte Cells					
12. PERSONAL AUTHOR(S) M.Z.A. Munshi, R. Gopaliengar, & R.B. Owens					
13a. TYPE OF REPORT Technical		13b. TIME COVERED FROM 7/15/85 TO 5/30/88		14. DATE OF REPORT (Year, Month, Day) May 1988

Corrosion Phenomena During Overcharge
in Polymer Electrolyte Cells

Department of Chemical Engineering and Material Science
Corrosion Research Center
University of Minnesota
221 Church St. SE
Minneapolis, MN 55455
USA

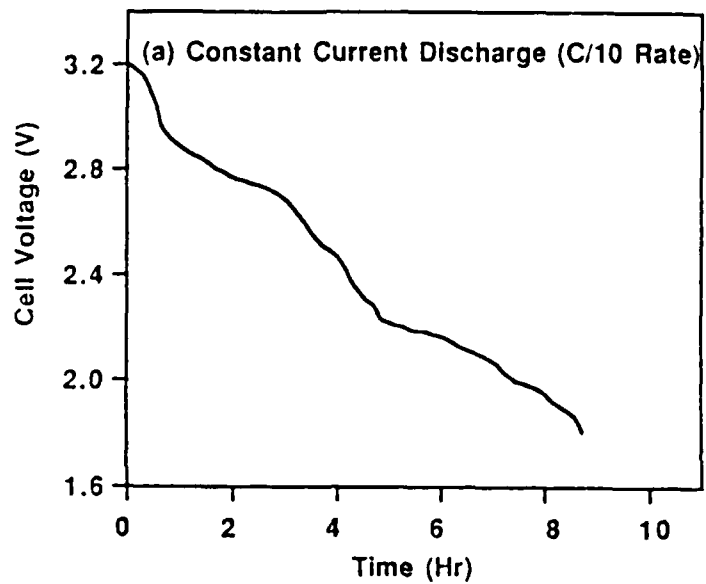
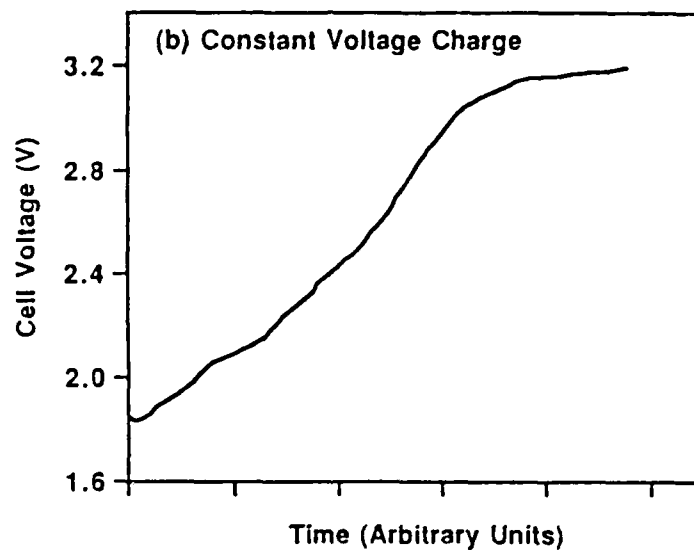
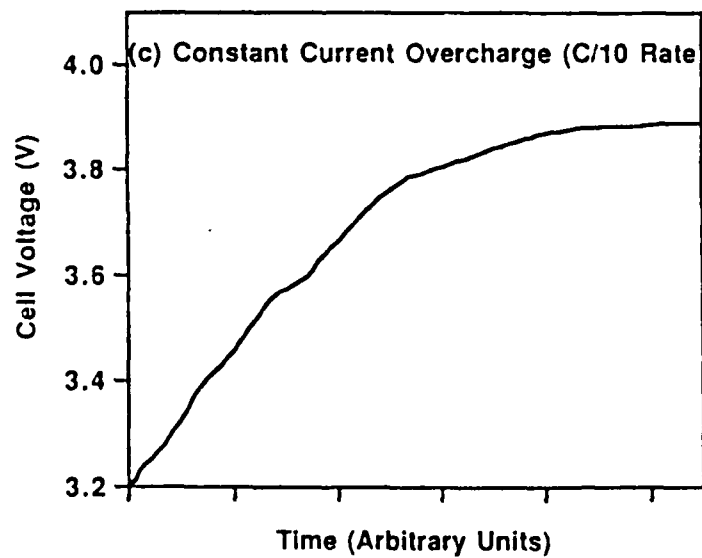
Figure 1. Cycling profiles for the polymer electrolyte cells.

Figure 1 shows the cycling sequences for the polymer electrolyte cells. Figure 1a depicts a typical constant current discharge followed by a typical constant voltage charge (Figure 1b) through a current limiting resistor. The constant potential is maintained across the fixed resistor and the cell such that as the cell charges, the voltage drop across it increases with a corresponding decrease across the fixed resistor. The current flowing through the cell decreases until the cell is fully charged. Once the cell has attained stabilization in capacity with cycle number and the coulombic efficiency in the final charging cycle has reached close to 100%, the cell is placed on overcharge at the C/10 rate. A voltage-time profile for cell #1 utilizing a thin cathode is shown in Figure 1c. In this case the cell stabilizes at 3.9V. The behavior appears to be quite different from cells utilizing thick cathodes [7] where the cell reached about +5V, sufficient to decompose the electrolyte.

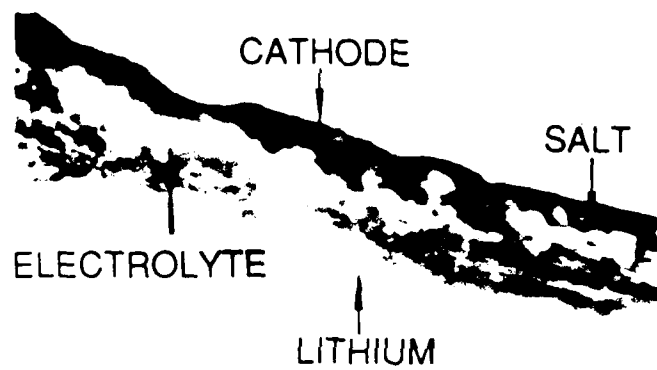
Figure 4. Cross-sectional view of cell #1

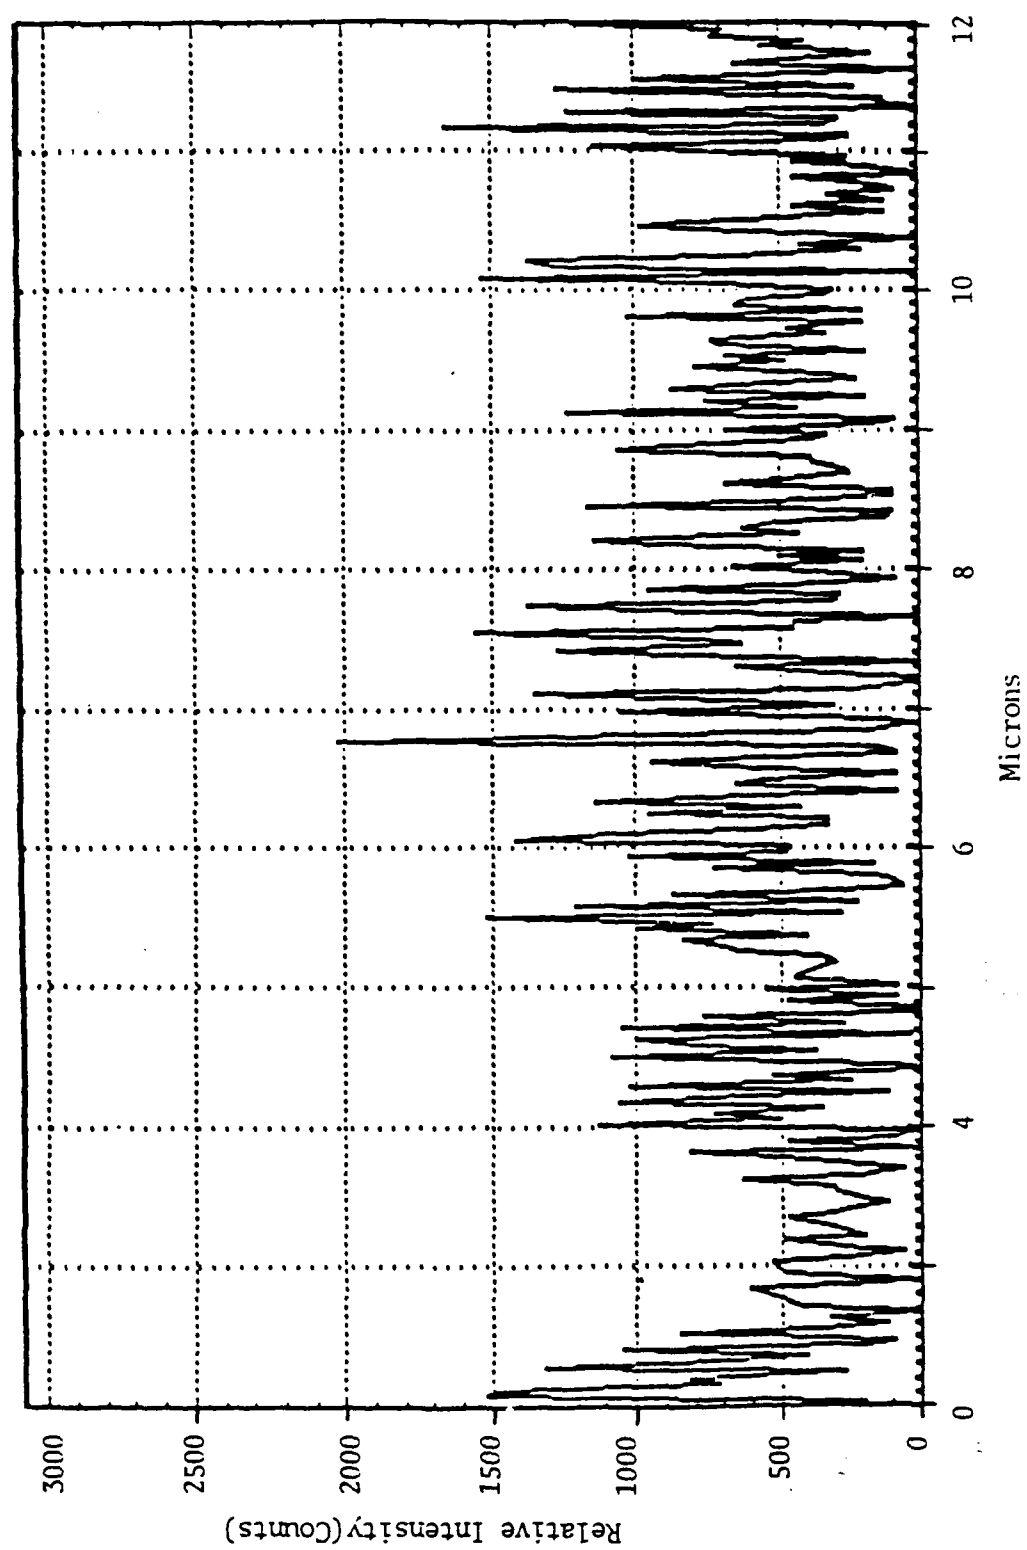
Figure 8. Auger microprobe line scan across the electrolyte cross-section for vanadium.

Auger microprobe analysis was made on the electrolyte cross-section for vanadium. Figure 8 shows such a scan indicating vanadium to be present virtually throughout the electrolyte.

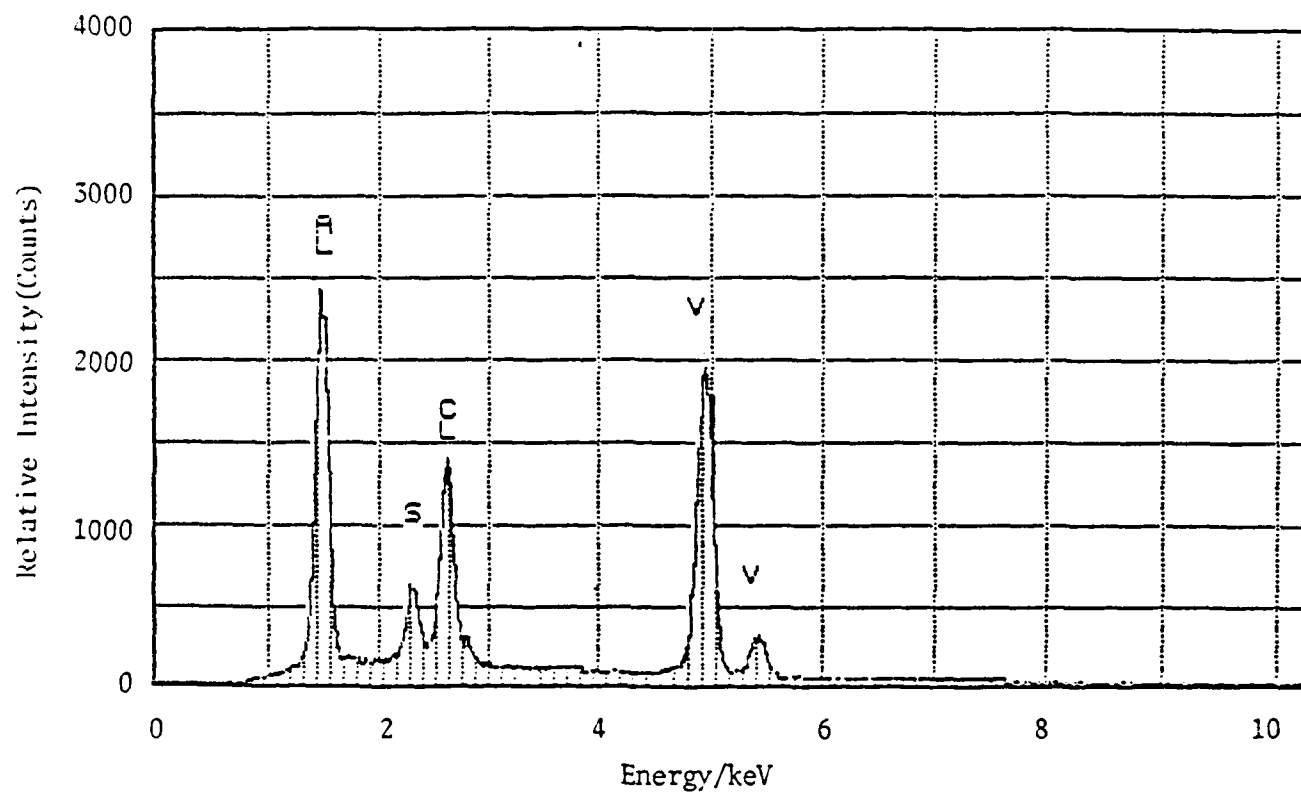
Figure 12. EDAX analysis of the lithium surface (cell # 4).

analysis of this surface indicated the presence of Al, Cl, S and V (Figure 12). A Cl x-ray map of this surface revealed that the Cl was situated in localized areas (Figure 13). More remarkable was that the Al was also only present in these same localized clusters (Figure 14). It is well known that Al has a strong affinity for Cl, but the presence of both elements in the same region may just be coincidental.

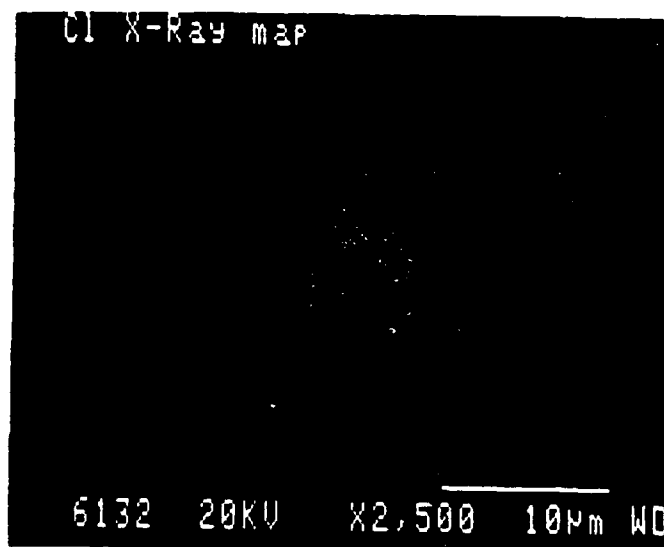
Figure 13. X - ray mapping of Cl on the lithium surface (cell #4).

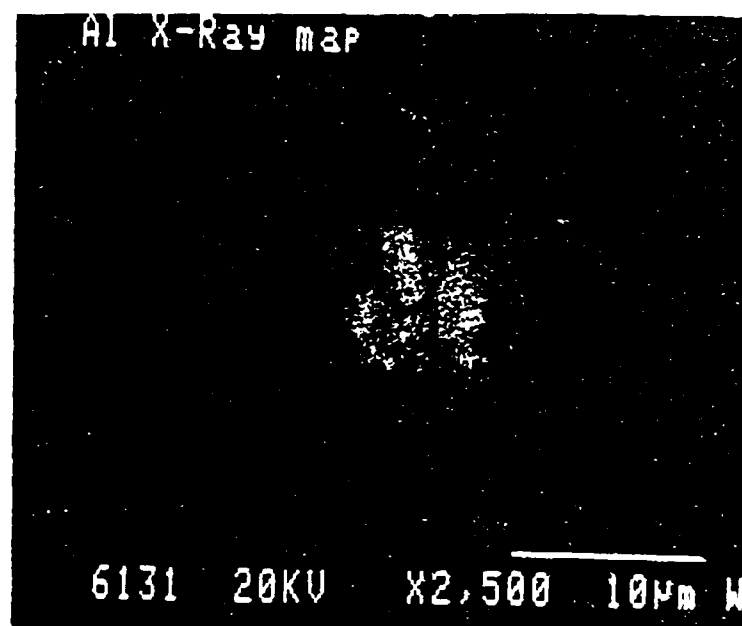
Figure 14. X - ray mapping of Al on the lithium surface (cell #4).
